CONDITION OF LOAN FORM
Condition Report
 (for incoming loans)

Objects of the Misanthropocene, a Time Travelling Exhibition of Insouciant Objects from the Museums of Beyond.

~~OBJECT: Grab and run pack~~

ACCESSION NUMBER: Temporary loan number 0011

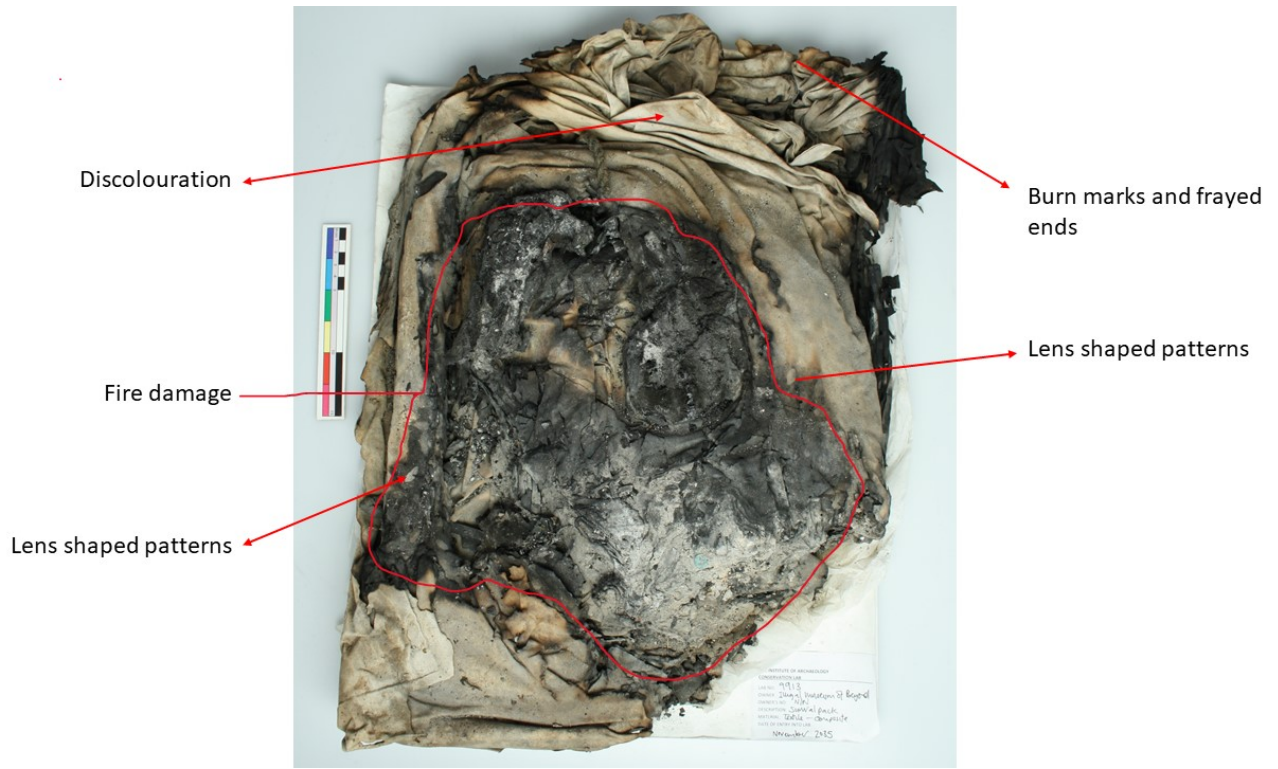
This survival pack is a composite object made with a textile outer layer, beige or white in colour. Several objects are bundled inside the textile layers. X-ray images of the survival pack were taken to provide information about the objects inside. The pack has burn marks on the most of its surface. The fire damage appears to be concentrated at the centre (see Figure 1).

The textile layer has dust and ash all over its surface. There are signs of discolouration, that may have been caused by the fire or burrial. The frayed areas of the textile have burn marks. This indicates that the damage to the textile layers may be caused by the fire and not by burrial. Lens shaped pattern some layer of the textile has a lens shaped pattern. This may be a pattern printed on the textile or lost decorations may have left this pattern on the surface.

Figure 1: overall condition

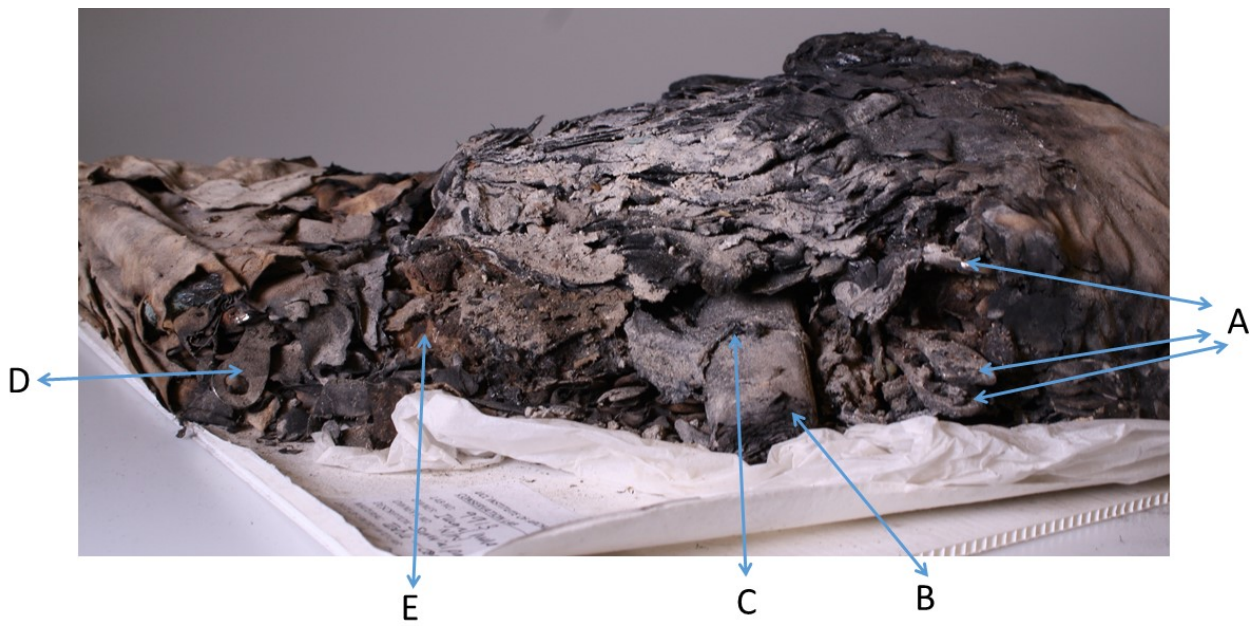
Lower right corner of the object has been lost, possibly due to the fire damage. It is possible to examine the layered structure of the object in this area (see Figure 2). This area is severaly damaged by the fire, therefore it is difficult to visually identify all the contents. Application of a small amount of force causes this area to crumble. The identifiable objects in this area are highlighted in Figure 2. Three strips of metal (A in Figure 2) are visible in the top corner of the lost area. From the x-ray, they appear to be utensils (1 in Figure). Next to the utensils, there is a roll of layered and thin sheet material (B in Figure 2), possibly paper or textile. The roll is tied with a ribbon shaped material (C in Figure 2), of about 0.3cm wide. The thickness of the material indicates that it could be rubber or textile. It is possible that some object is wrapped inside this roll. Another metal component, located at the bottom, appears to be some tool like object in the xray (D in Figure 2 and 2 in Figure 6). Above the metal tool, some of the layers of the object has pastic-like texture (E in Figure 2). These layers are somewhat translucent and glossy.

Figure 2: lower right corner

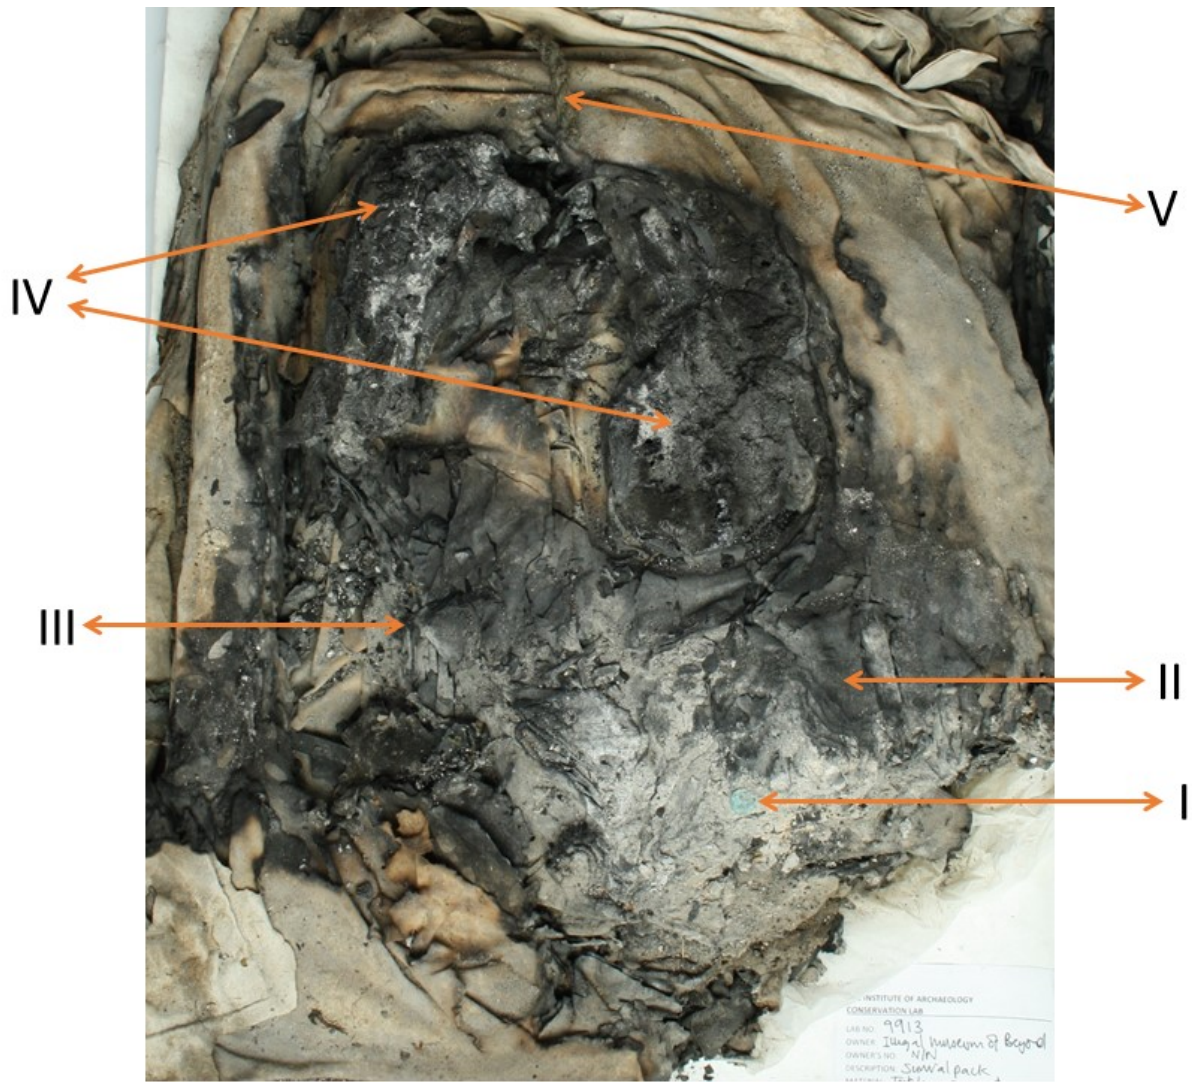
The center of the of the object has the most fire damage. Most of the ash as concentrate in this area. A circular greenish blue disk (I in Figure 3), about 1 cm in diameter is visible in this area. It could be some corroded metal. From the x-ray, several circular disks are present in this area. One of them looks like a button. Therefore it is possible that this area has remains of clothes. Some of the less damaged parts of these layers have denim like texture (II in Figure 3). Part of a soft black rope, about 0.3 cm wide is also visible in this area (III in Figure 3). In the top part of the burned area, remains of 2 black object are present (IV in Figure 3). From the shape and the texture of the burned material, it is possible that they are made of leather and rubber. Due to the presence of clothes and from the appearance of these objects, it is possible that these are the remain of a pair of shoes. The black object on the left is not attached to other parts of the objects. It has some markings on one of its sides (see Figure 4). Above the black objects, part of a greenish blue rope (abobut 0.8 cm in width), is portruding from between the layers of textile (V in Figure 3). This rope possibly made of plastic.

Figure 3: detailed condition issues

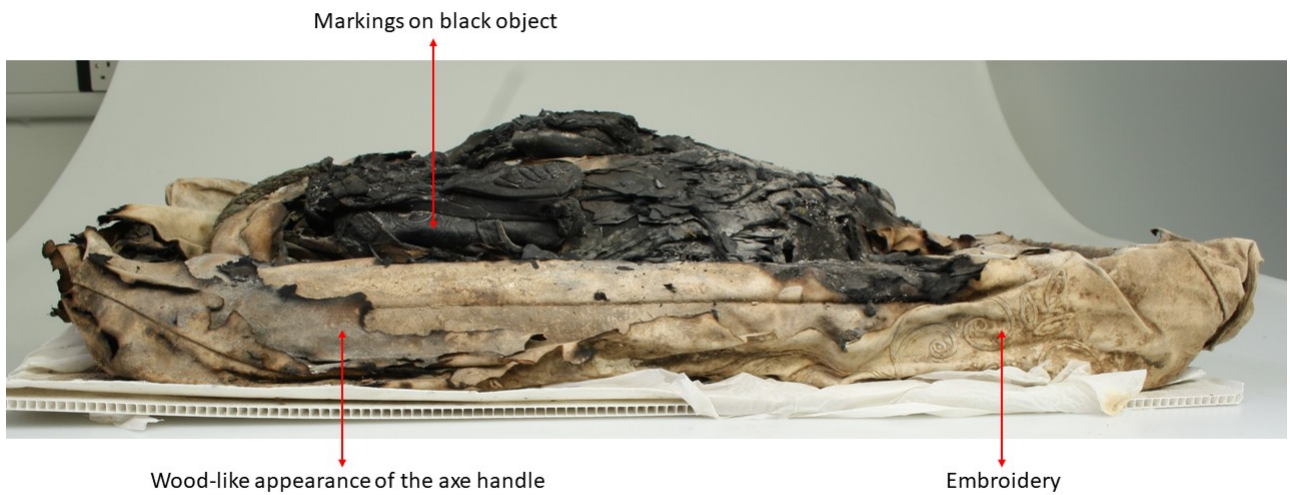
The textile left edge of the object has embroidery made with a thread similar in colour to the the textile (see Figure 4). The left edge also has a piece of rope portruding through layers of textile. At the top edge of the object, layers of textile are srunched up. In between the layers, some area of the textile has embroidery (see Figure 7). This area is heaviily soiled.

Figure 4: left edge

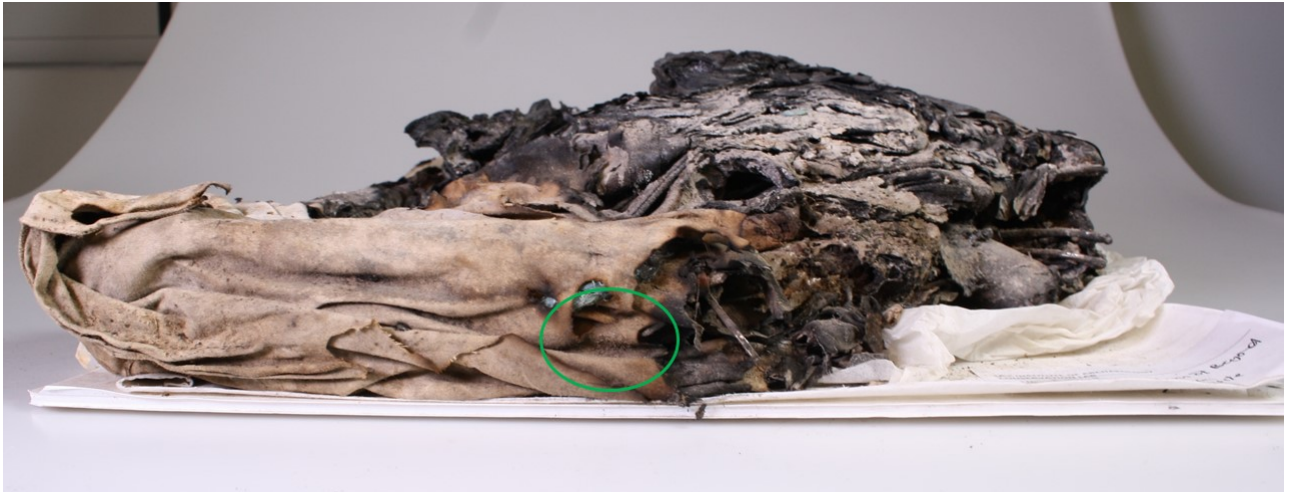
At the bottom edge of the object, part of the rope (similar to the rope mentioned before) is visible (see Figure 5). At the bottom left corner of the object has a more definite shape than the rest of the object. From the x-ray, this corner has an axe shaped object (3 in Figure 5). The x-ray also indicates that additional metal tools are under the axe head (2 in Figure 5). The handle of the axe makes up most of the left edge of the object. The handle is mostly covered by the top textile layer. However, the texture of the exposed part of the handle indicates that it is possibly made of wood (see Figure 4).

Figure 5: bottom edge

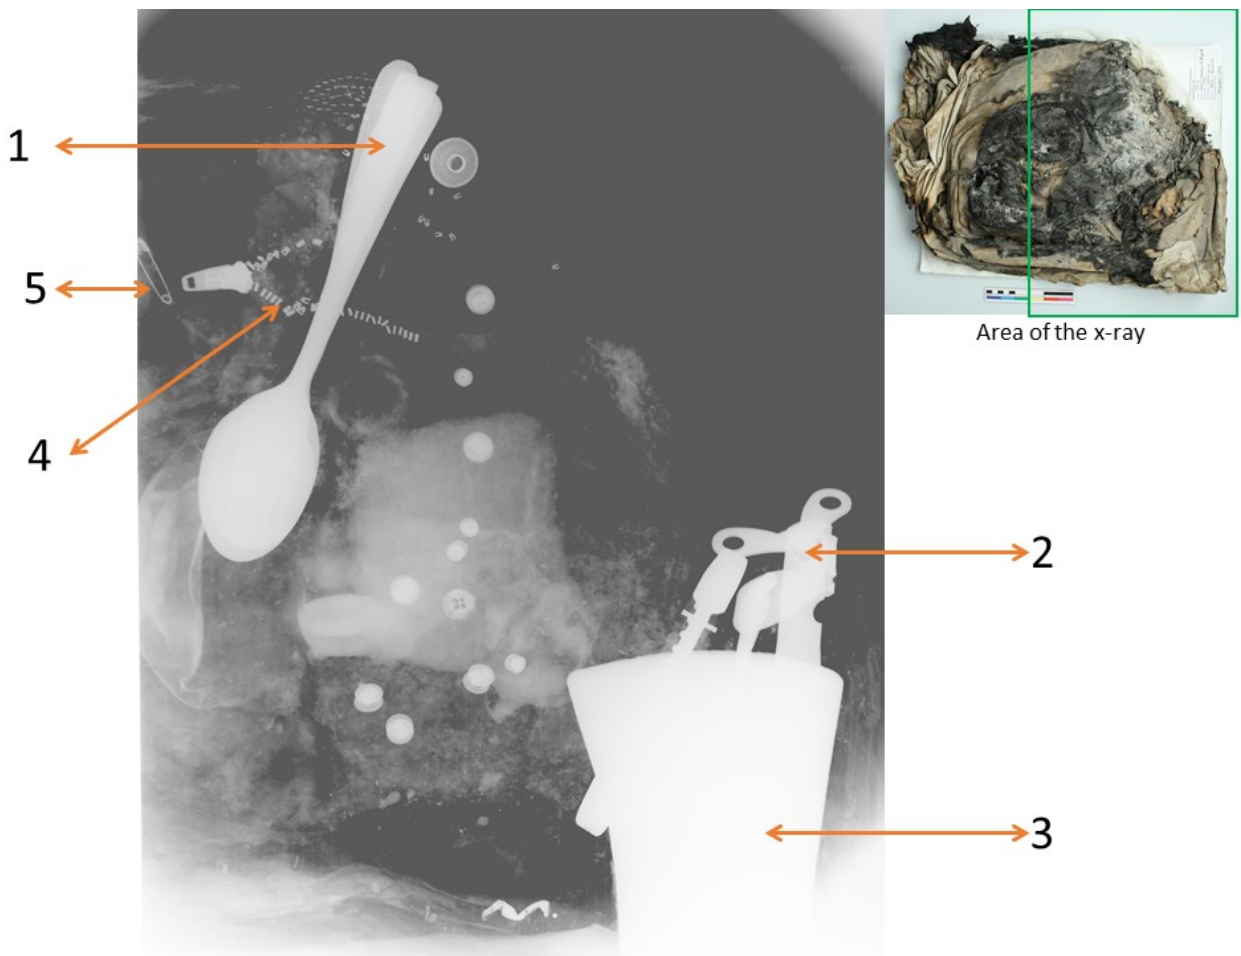
X-ray of the object revealed more information about the contents of the survival pack. There are 2 tools under the axe head. Near the utensils, the broken zipper is visible (4 in Figure 6). Just above the zipper there is a bunch of needles and a saftey pin (5 in Figure 6). Several other components of the pack are made visible by the x-ray, but they are unidentifiable without further information about the object.

Figure 6: x-ray of the lower half

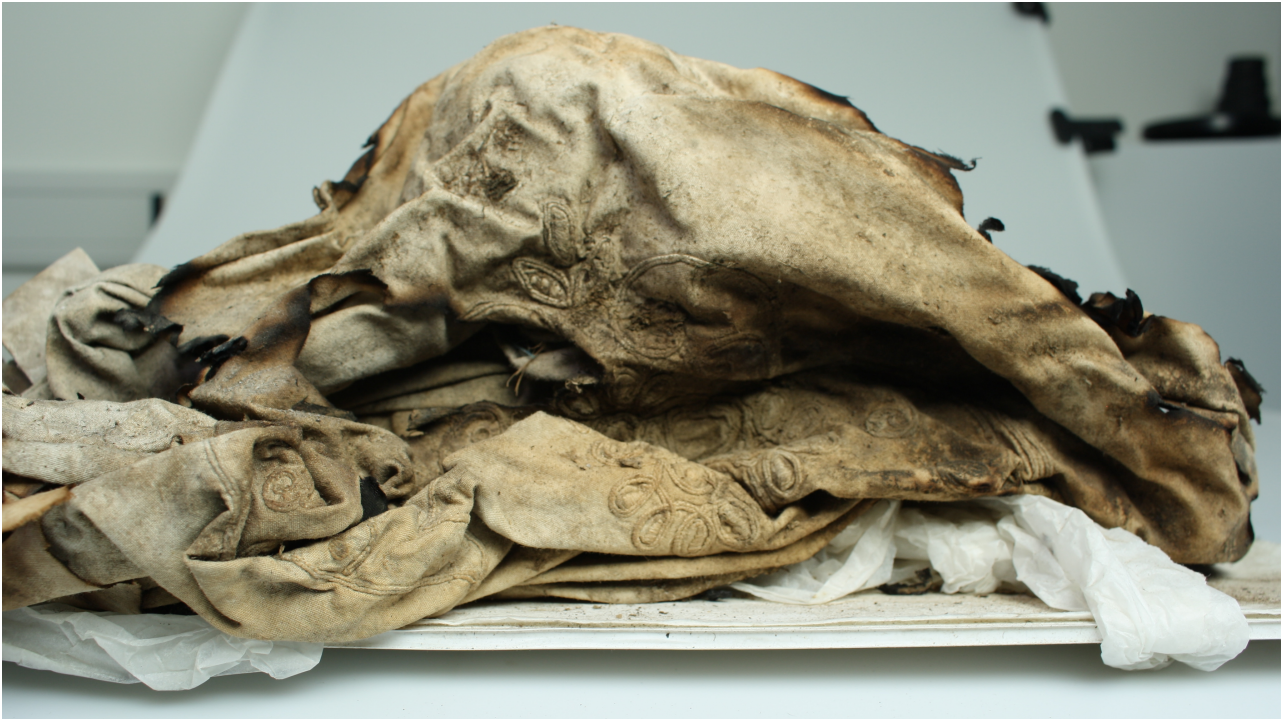
Figure 7: embroidery on the scrunched up layers at the top edge
